Preventing waste in production: industry examples

This Good Practice Guide was produced by
Envirowise

Summary

This Good Practice Guide consists of ten Industry Examples. These demonstrate how ten companies in the UK used analysis of production data to improve control of their processes and achieve important cost savings and environmental benefits.

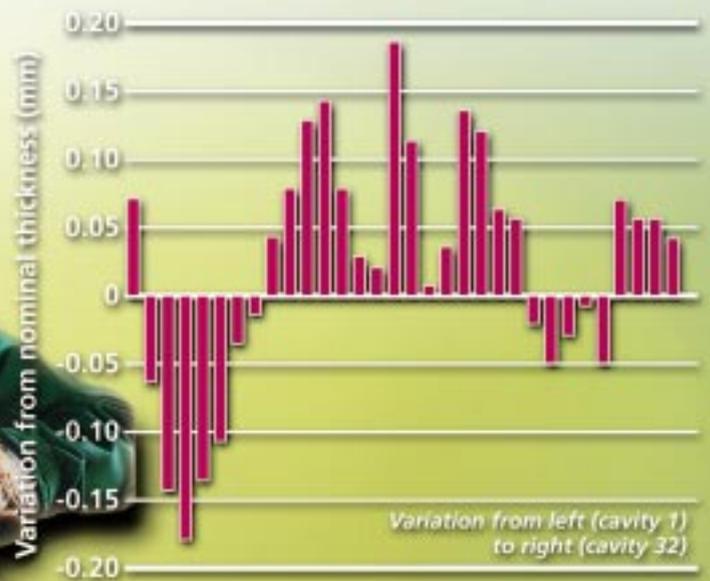
Variation in mean thickness across the mould

Variation from left (cavity 1) to right (cavity 32)

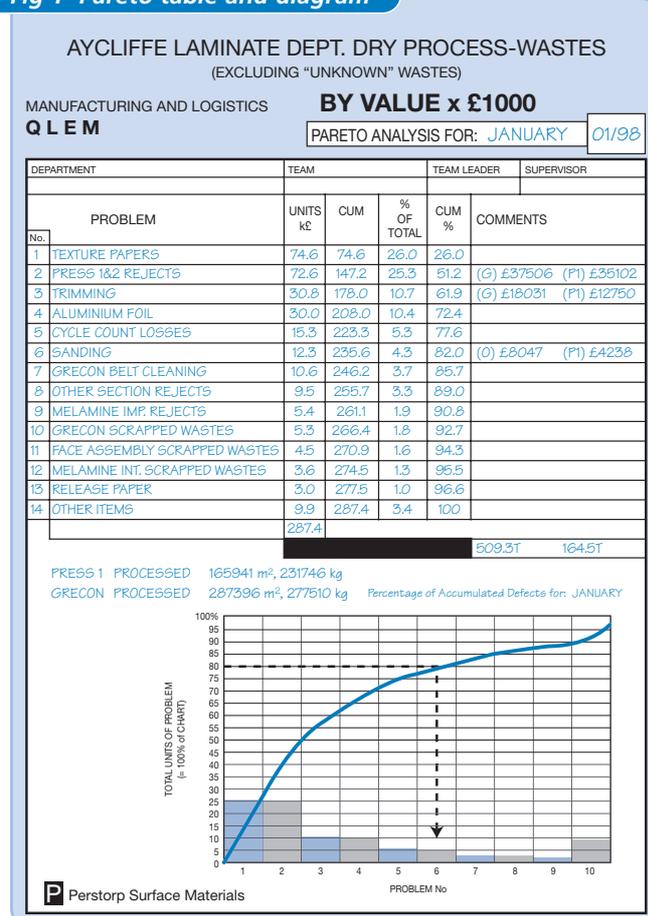
Fig 1 Pareto table and diagram

Departmental teams monitor key performance indicators such as waste, yield and 'housekeeping', and display the findings on boards in their work areas. Numerical techniques such as Pareto analysis¹ are used to show the nature and extent of the problems identified, and the associated financial implications. Plotting the findings on a Pareto diagram (Fig 1) provides a visual

representation of the problem, highlights where action might be taken to improve the situation, and can be used to track the results of these actions during subsequent months.

Using Pareto analysis highlighted a costly problem that originated in the Bonded Components Department: some of the laminated tops were coming apart over a period of several months after installation and were being replaced under Perstorp's long-term performance guarantee policy. The Pareto diagram histograms showed that these failures started immediately after installation, built up after six months and continued to occur for more than a year.

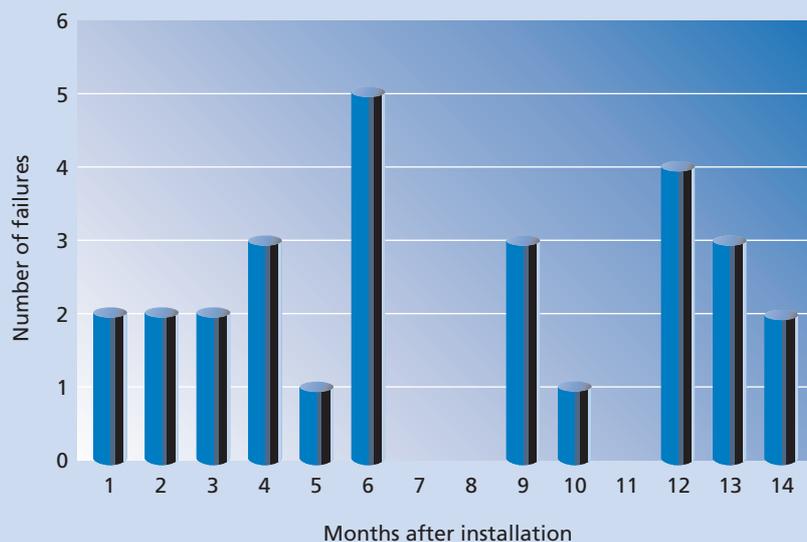
Fig 2 Laminated top failures reported during the three months prior to production modifications

During the three months preceding the production modifications, the number of reported failures was 28 (Fig 2), which was equivalent to 112 per year. Following the modifications, the reported failures have dropped to less than 50 per year, a reduction of more than half. Confirmed levels of improvement to date are equivalent to an annual saving to the company of around £15 000/year.

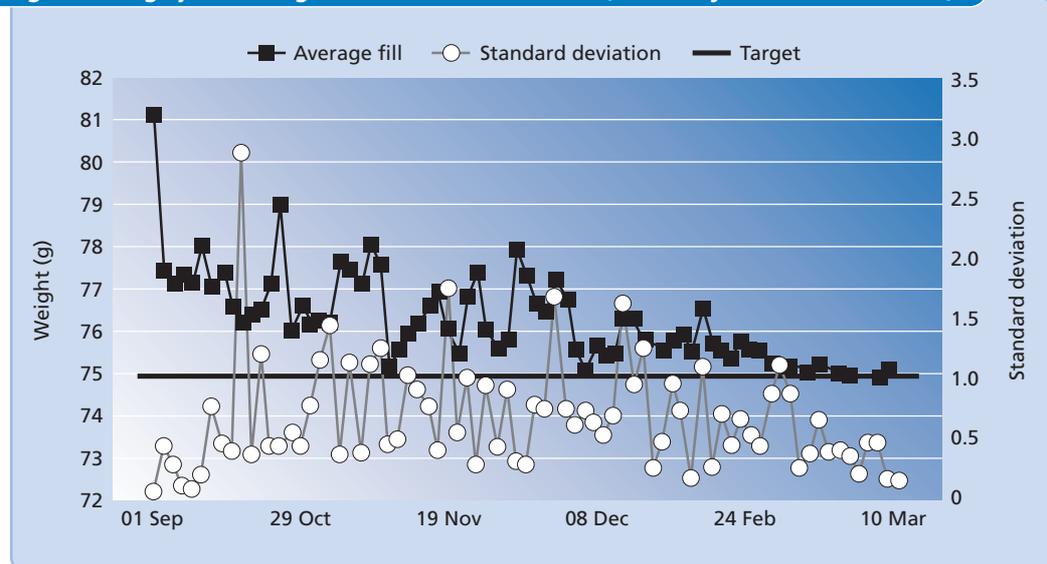
Fig 1 Average jar fill weights and level of variation (shown by standard deviation)

Over a six-month period, the standard deviation of the fill was reduced from more than 1 g to less than 0.3 g (Fig 1). The capability index of the process improved over the same period to a Cp value of 2.15, which is similar to that achieved in many engineering processes. As a result, Shippams safely reduced the target fill weight and reduced overfill from 3% to less than 0.3%. There was also a reduction in jar reject level.

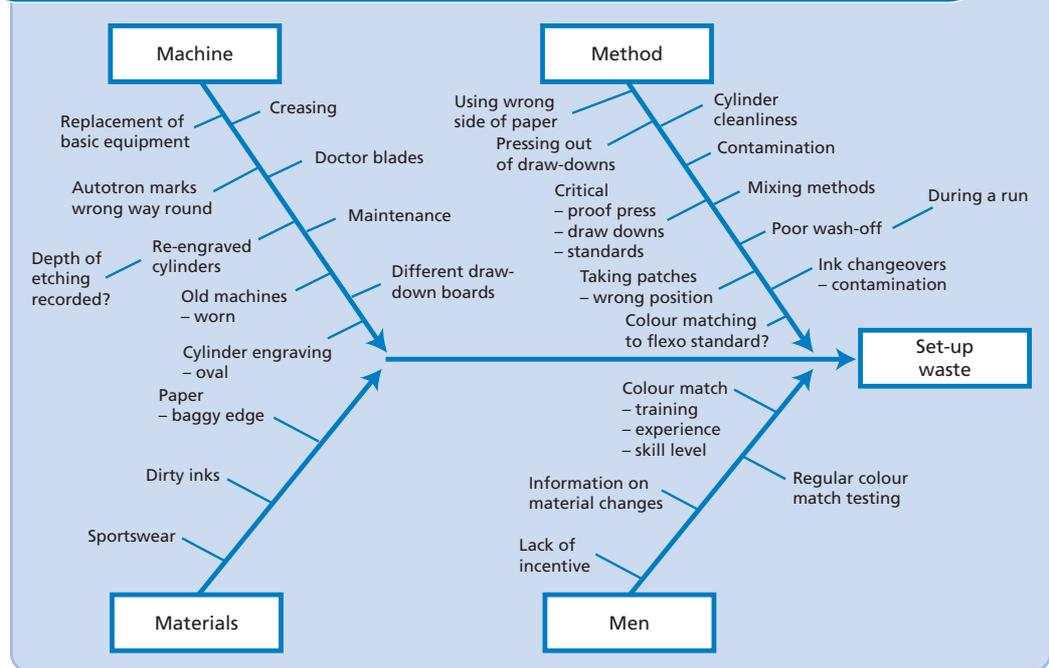
Fig 1 Cause and effect diagram summarising the conclusions of the Green Shift brainstorming session

Each shift team held brainstorming sessions and used a simple cause and effect 'fishbone' diagram¹ to focus the discussions. This approach identified a number of areas of concern (Figs 1 - 3), and the results were then pooled so that each shift had access to all of the ideas resulting from the brainstorming sessions.

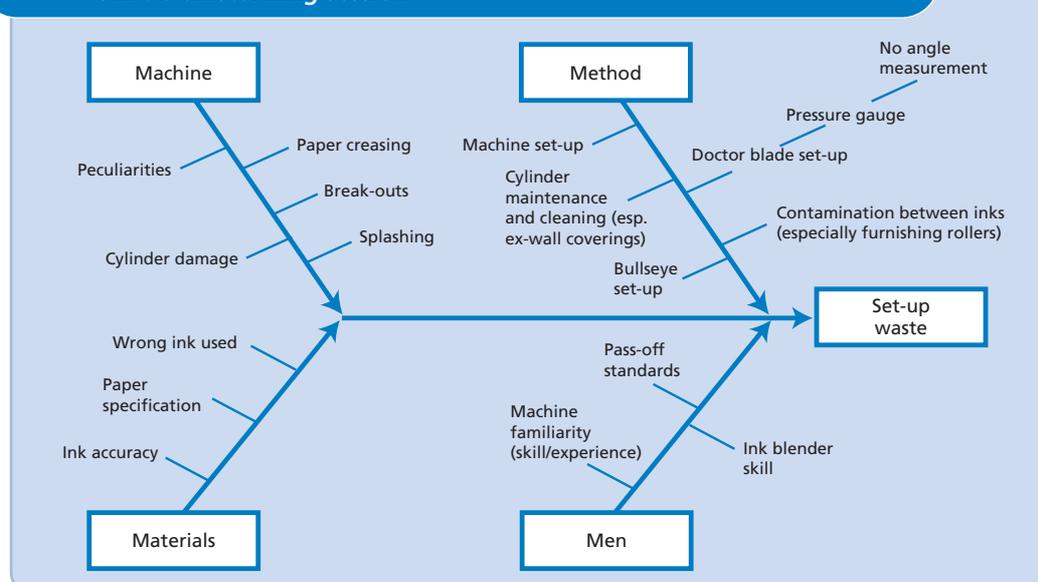
Fig 3 Cause and effect diagram summarising the conclusions of the Yellow Shift brainstorming session

The results of these three brainstorming sessions were pooled and discussed. Three main problems were identified. Each shift agreed to address one problem.

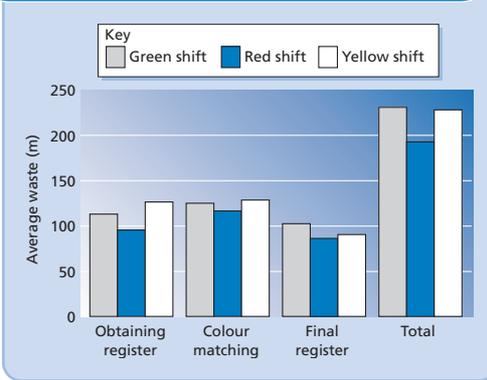
Fig 4 Set-up waste for all machines by shift and by set-up component

Examination of the diagrams raised a number of questions:

- Why do some jobs generate more than 100 m of set-up waste while obtaining print register?
- Why has Green Shift the best performance on P8 but the worst performance overall?
- Why was Yellow Shift's register waste on P8 almost double that of the Red and Green Shifts?

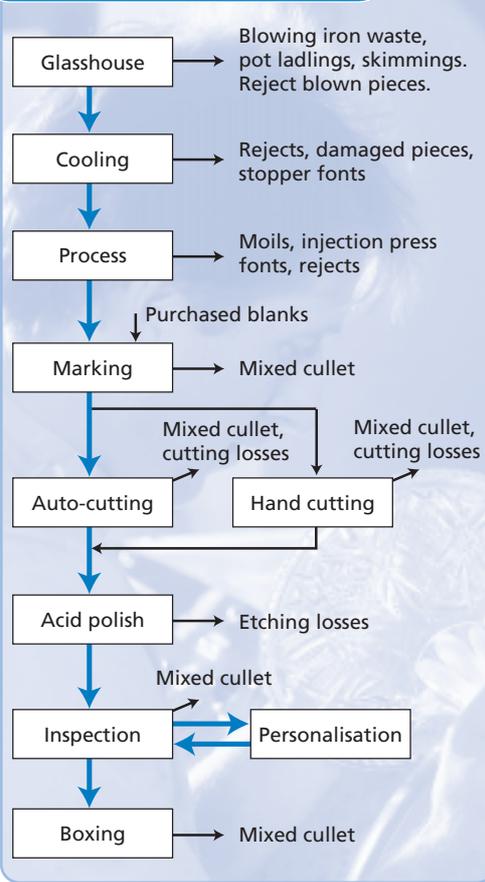
Fig 1 Flow diagram of crystal production process

Initially, there were many opinions within the company as to the main causes of breakage. A flow diagram was prepared and refined to show all the significant breakage points (Fig 1 overleaf). This was then used as a basis for discussions as to where the greatest losses occurred.

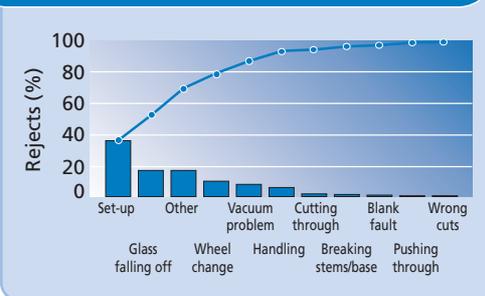
Fig 2 Pareto diagram of problems experienced during wall cutting

- wall cutting - set-up difficulties accounted for nearly 40% of losses (Fig 2);
- star base cutting - stem/base breakage accounted for nearly 50% of losses (Fig 3);
- variable-depth cutting machine - vacuum system problems accounted for nearly 60% of losses (Fig 4).

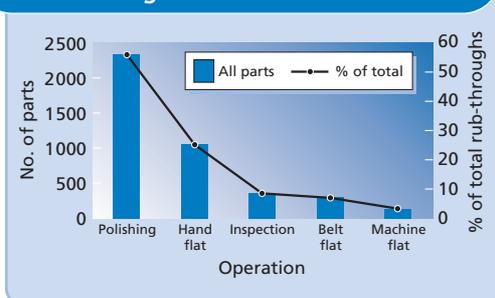
Fig 1 Pareto analysis of where rub-throughs are found

'Rub-through' is a problem that occurs during polishing when too much of the surface lacquer is removed, exposing the walnut veneer and causing the component to be rejected. It is a major cause of defects.

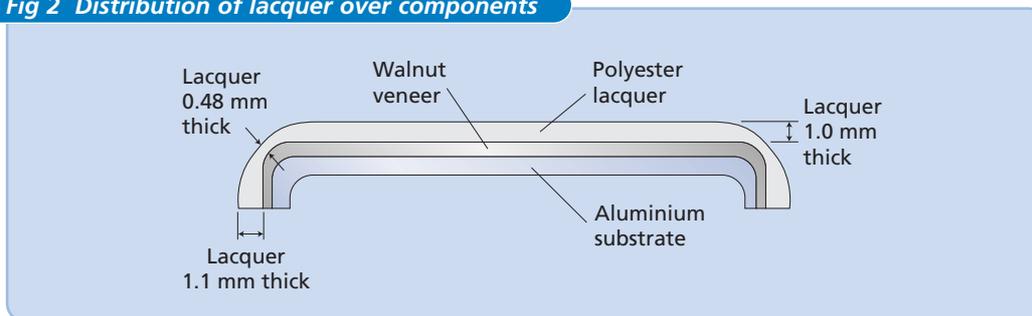
Fig 2 Distribution of lacquer over components

The company calculated that the probability of rubbing through on the corners was at least 12%, ie that one in every 8.3 components would suffer from 'rub-through'. They also found that lacquer removal was highly variable during flatting, even without this 'corner effect'. One possible cause identified was the range of different ways of using the machine flatting equipment - no standard process method had been defined.

A series of trials was carried out to establish the best flattening technique for minimum lacquer removal, and this was established as the standard method. Trials were also carried out using various coating conditions and different numbers of coats to reduce the corner thickness problems.

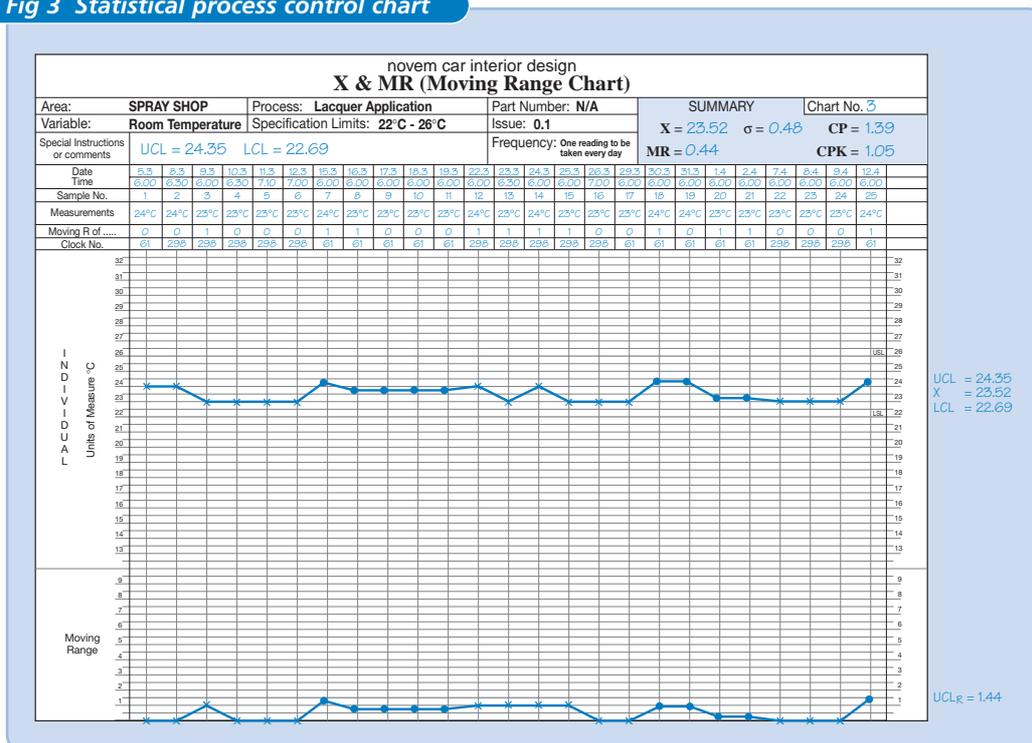
Fig 3 Statistical process control chart

Shortly after the new procedures had reduced rub-through levels, the problem appeared to return - but in a more severe form. Investigation showed that, in this instance, the lacquer was cloudy and spotted, and operators were overpolishing to compensate. After several trials, the cause of the problem was traced to temperature variations in the lacquer shop - a temperature above 26°C caused low viscosity and a cloudy coating, while a temperature below 22°C created problems of aeration and spotting. A statistical process control chart (see GG224) was introduced to help operators control lacquer room temperatures at the appropriate level (Fig 3), and this approach resolved the problem.

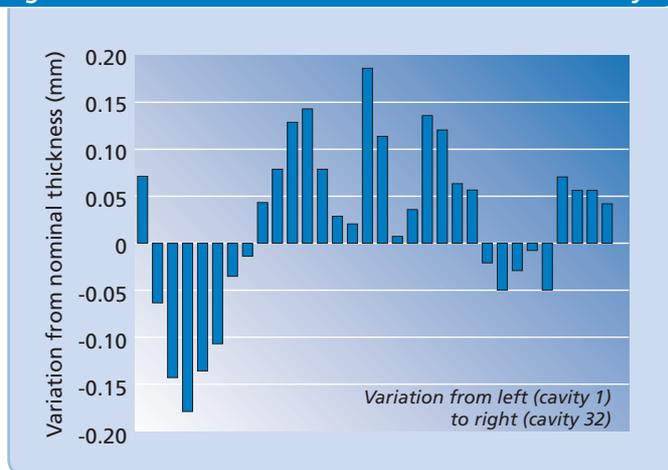
Fig 1 Variation in mean thickness for each mould cavity

Office equipment demands tight tolerances, so it is critical for the company to minimise variability to reduce its reject levels and costs. However, the operator responsible for the production of one moulded rubber component noticed that the thickness of the finished components appeared to vary with the mould cavity in which the component had been formed. This suggested that there was a 'special' (and, therefore, controllable) cause of variation, which could be tackled to reduce reject levels.

The change to a larger press reduced distortion and the variation in thickness level by 50%. This increased the capability of the process¹ to a point at which scrap was virtually eliminated, and gave the company estimated savings of more than £10 000/year.

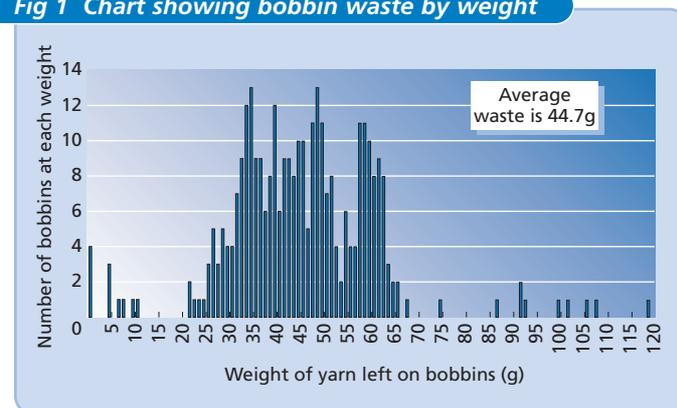
Fig 1 Chart showing bobbin waste by weight

The company was aware that levels of yarn waste appeared to be significant and asked shift operators to collect relevant data. The data were used to generate a histogram (Fig 1). The results showed that the typical variation in yarn length on a roll was such that, on average, 300 m (45 g) was being left on each roll, representing a scrap rate of almost 1%.

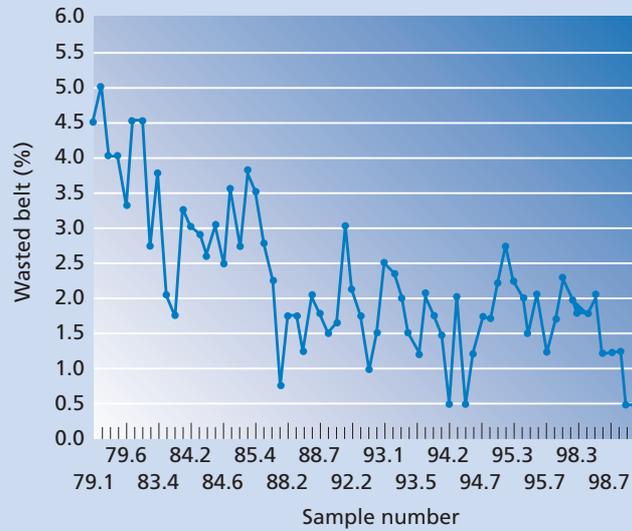
Fig 1 Improvements in length control on Loom M6

During the first year, FCB reduced its excess length production from 5% to 2%, a saving worth £104 500/year. In subsequent years, FCB has continued to benefit from this saving and has further developed its SPC systems. Fig 1 shows how length control has been improved on one loom.

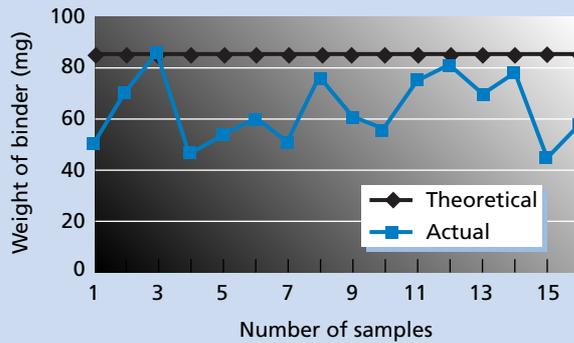
Fig 1 Theoretical and actual binder addition rates with manual calibration

The foundry installed an automatic mixer control unit, which incorporated flowmeters, sand temperature monitoring, visual alarm systems and a programmable logic controller (PLC). The unit uses data on resin flow and sand temperature to calculate and achieve the optimum catalyst addition rate.

These findings encouraged the foundry to move closer to process optimisation by reducing the proportion of binder added to the sand. The resin addition rate was reduced from 10 kg/minute (1.22% of resin to sand by weight) to 8.89 kg/minute (1.09% of resin to sand by weight), still with a much reduced level of defective moulds.

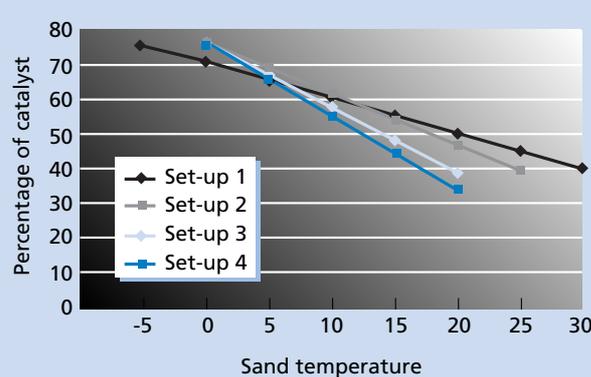
Fig 3 Changes in catalyst addition rates at higher sand temperatures

The foundry also suspected that the mathematical rule used to calculate the rate of catalyst addition for different sand temperatures was too generous at higher temperatures. The foundry gradually reduced the quantity added at higher temperatures from Set-up 1 to Set-up 4 (Fig 3), again maintaining adequate mould strength and setting times.
